# **Model of water leakage beneath reservoir and above diversion water tunnel; Mae Prachum reservoir area, Mae Taeng District, Chiang Mai Province**

**Bureau of Engineering Topographical and Geotechnical Survey  
Royal Irrigation Department, Samsen rd., Bangkok, Thailand**

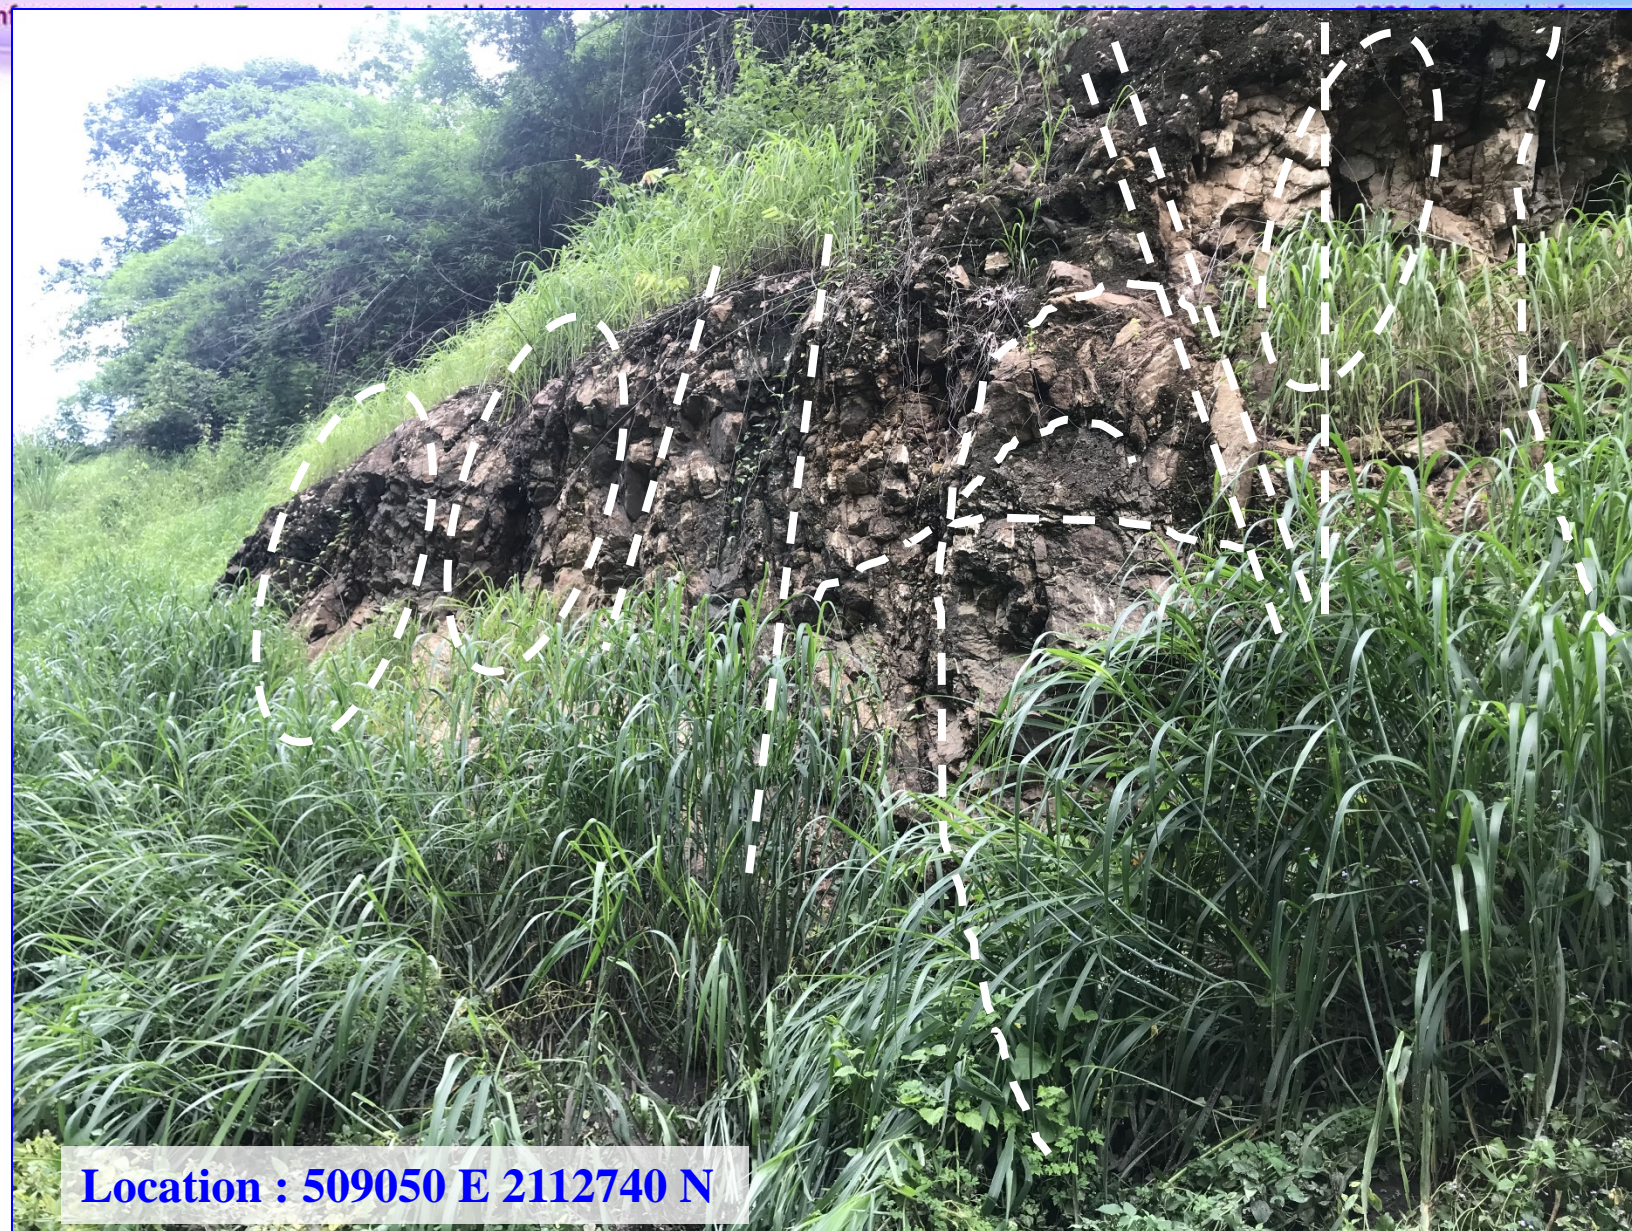
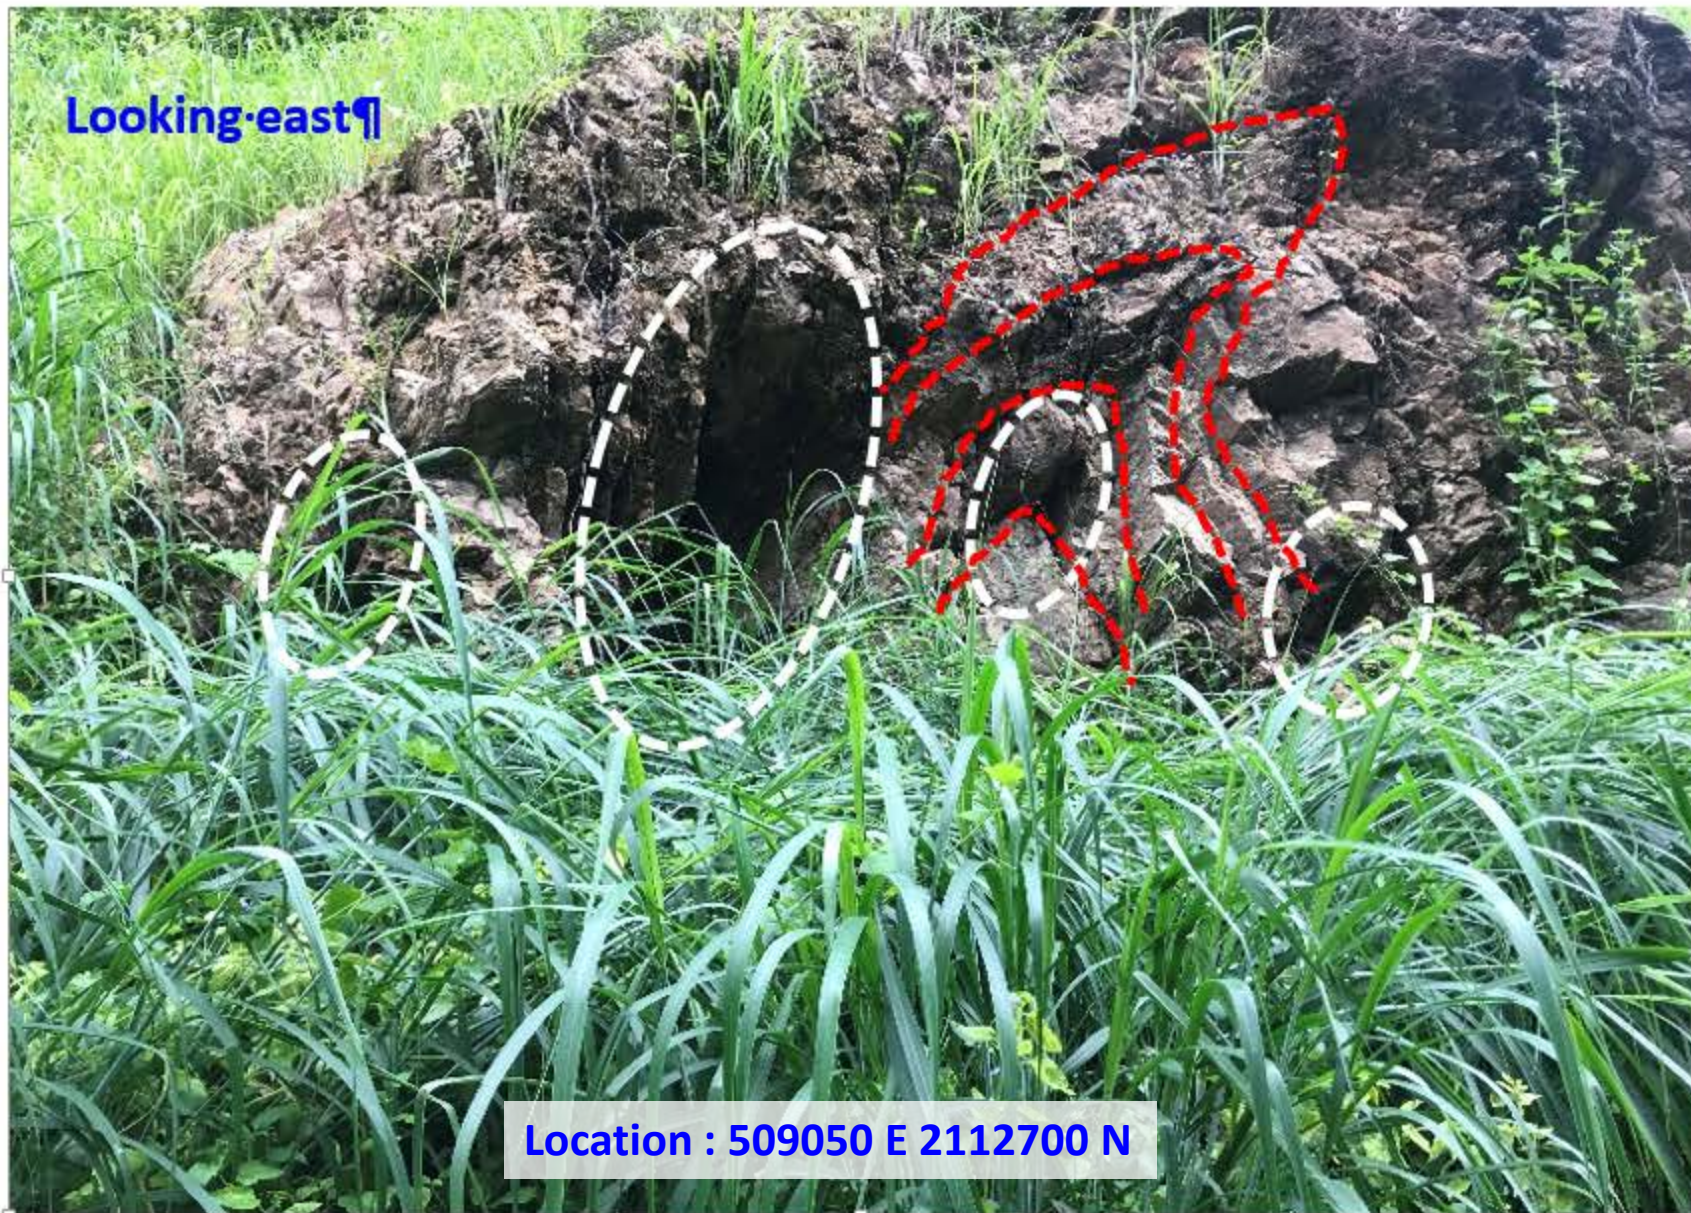
Fig.1. Rock exposures at Huai-Khun-Mi, showing opened joint, fracture, and cavity (white), associated with fold structure (red) as channels that water outflowing from reservoir.

Fracture (white dot)

Opened fracture  
(white ellipse)

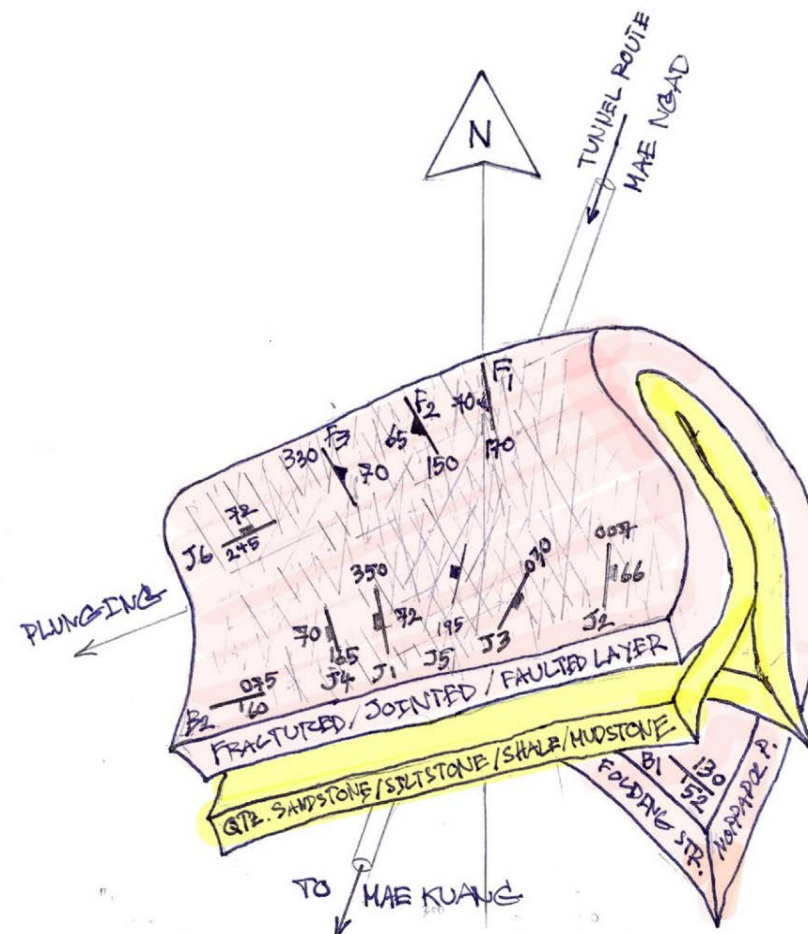
Stereo plot of discontinuities

Discontinuities  
Avr. N27°W 63°SW

Type	Strike/Dip (Right)
Fault 1	169/69
Bedding	140/48
Fault 2	150/72

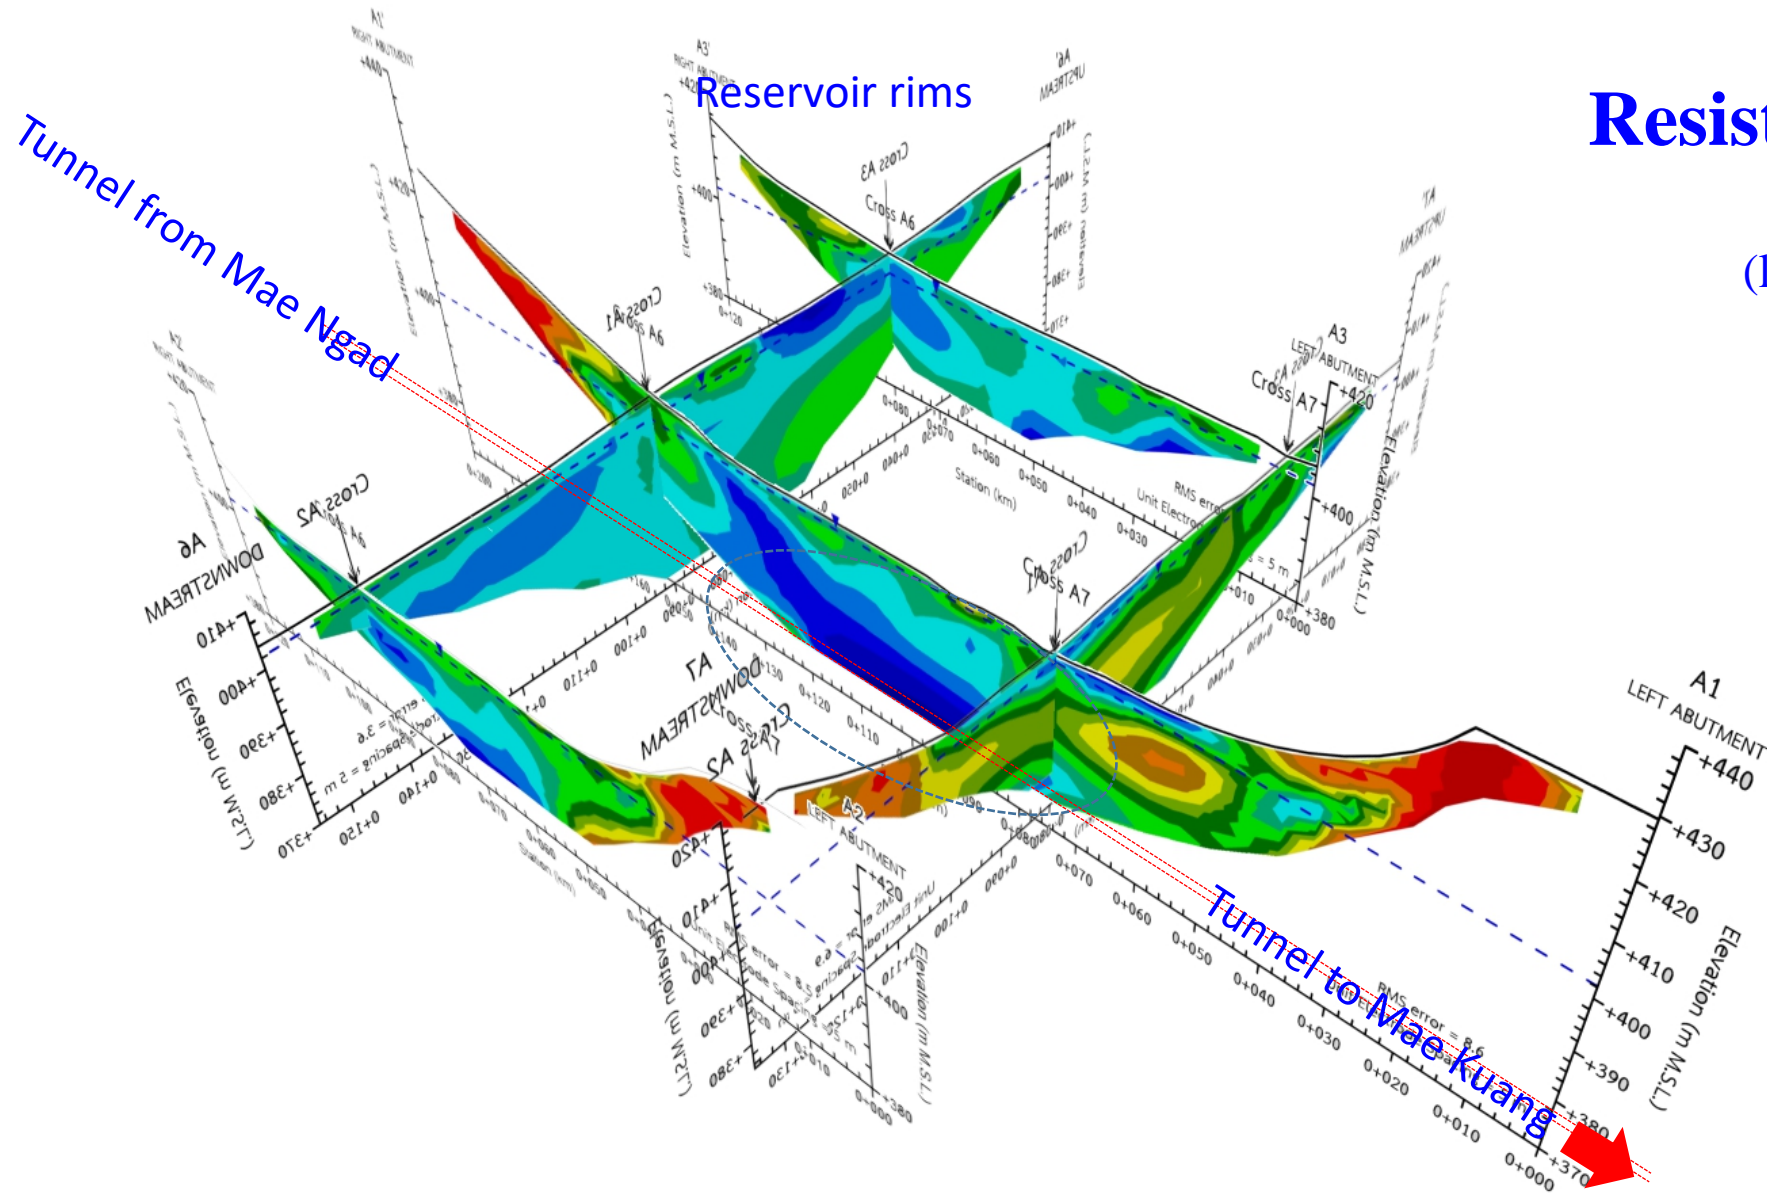
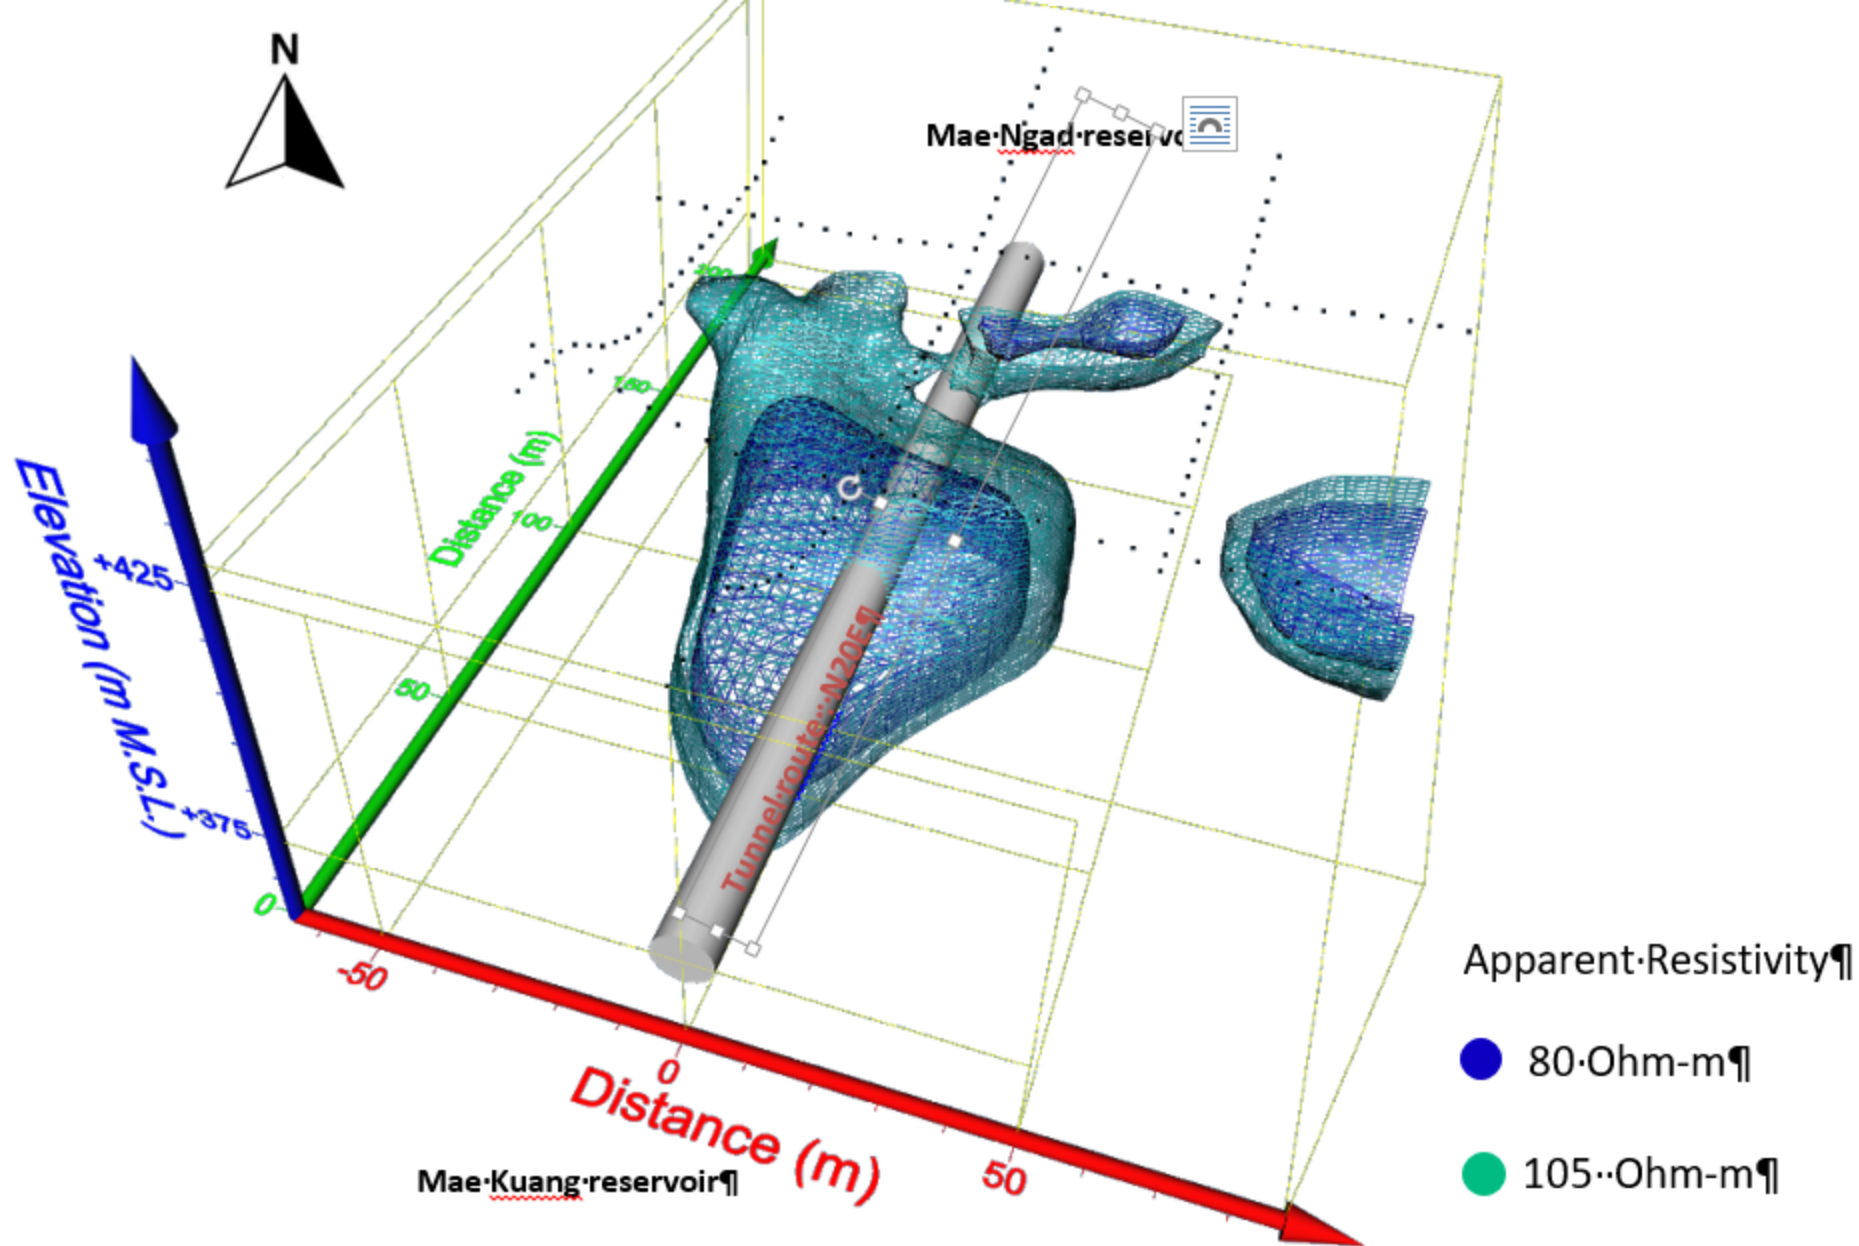
Fig. 2. Model of water leakage by using electrical resistivity imaging data.

Note: Tunnel direction = N20°E, scale X:Y:Z = 1:1:1

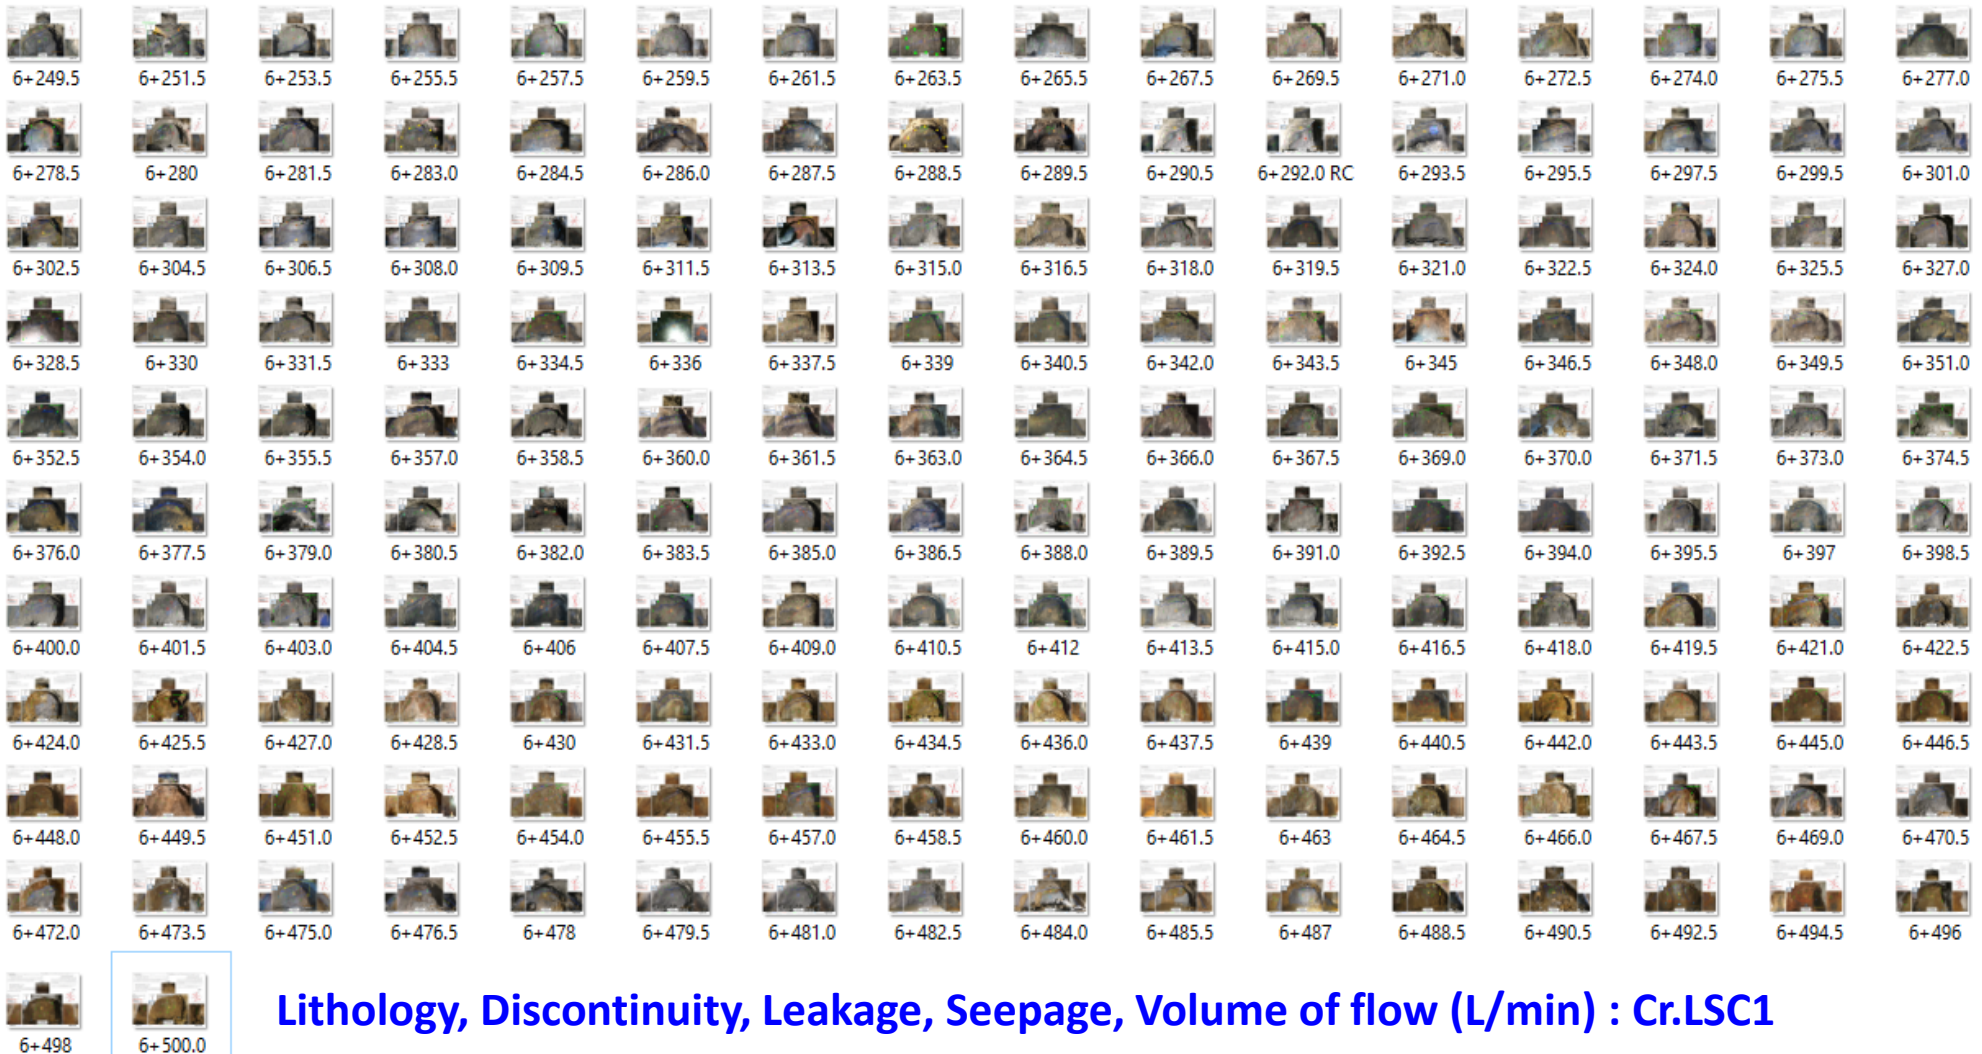
# 162 tunnel faces ; km 6+249.5 – 6+500.5

Lithology, Discontinuity, Leakage, Seepage, Volume of flow (L/min) : Cr.LSC1
