**Model of water leakage beneath reservoir and above diversion water tunnel;  
Mae Prachum reservoir area, Mae Taeng, Chiang Mai Province**

Noppadol Poomvises<sup>1st</sup>, Anchalee Kongsuk<sup>2nd</sup>, Benjamas Sawasdipong<sup>3rd</sup>, and Tanapon Suklim<sup>4th</sup>  
<sup>1234</sup>Bureau of Engineering Topographical and Geotechnical Survey  
Royal Irrigation Department, Samsen rd., Bangkok, Thailand  
npoomvises@gmail.com, noinarid@gmail.com, kaekai\_ben@gmail.com and tanaponsuklim@gmail.com

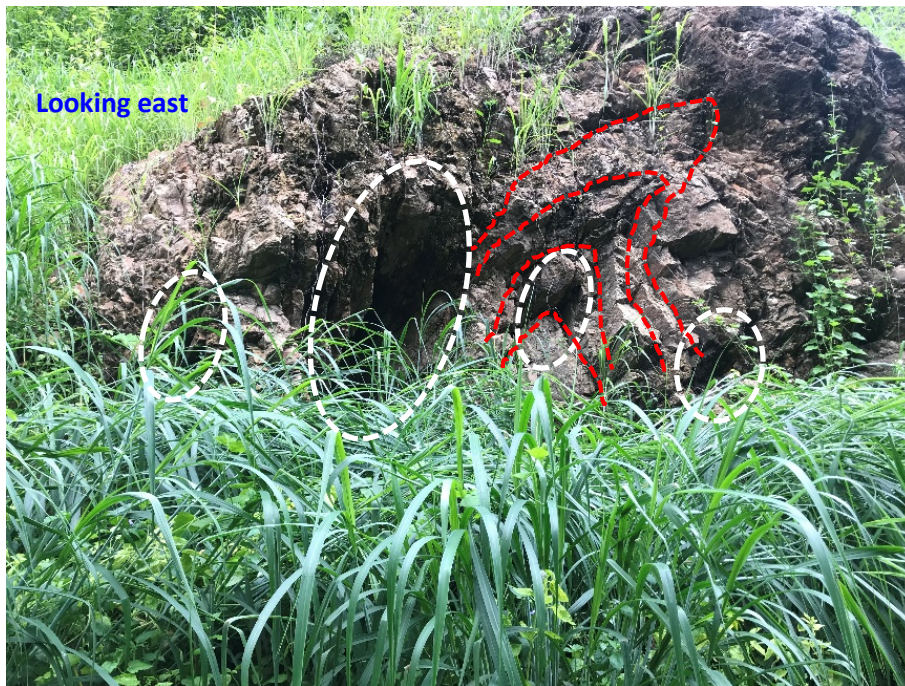
According to geological observations along Huai Khun Mi, an intermittent stream located near the eastern rim of the reservoir and nearly above the tunnel route, many rock exposures show evidence of opened joint, fracture, cavity, and associated fold structure. They are interpreted as the channel that water flowing out of reservoir (Fig. 1). Result of ERI modeling (Fig. 2), covering reservoir floor, clearly reveals anomalous bodies of low resistivity, interpreted as a channel of water from the reservoir above, which leaked down to the tunnel conduit below. In subsequent, combination of stereo plots of plane of bedding, joint, and fault, clearly shows the average direction of north 27 degree to west and dipping angle of 63 degree to west, which is interpreted as the opening channels that water flowing into tunnel conduit under the reservoir area.

Fig. 1. Rock exposures at Huai Khun Mi, showing opened joint, fracture, and cavity (white), associated with fold structure (red) as channels that water outflowing from reservoir.

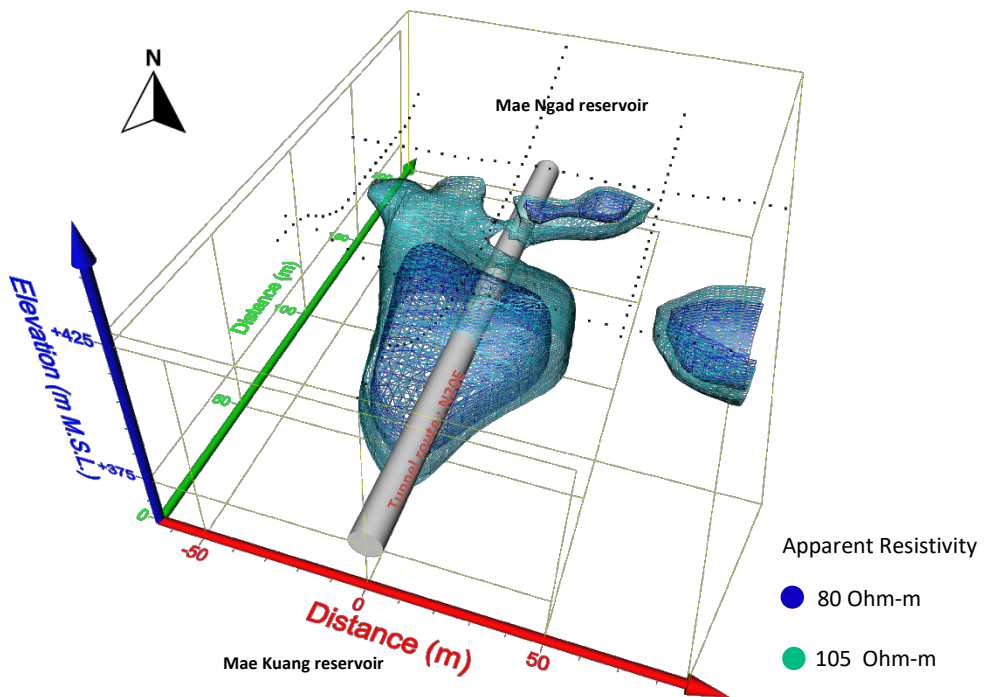
Fig. 2. Model of water leakage by using electrical resistivity imaging data.  
 Note : Tunnel direction = N20°E, scale X:Y:Z = 1:1:1

As results, the treatment of tunnel is preliminary conducted. After grouting intact rock around the conduit with suitable method, the problem of water inflowing is solved. The treatment of the reservoir floor will be the next step to make a remediation. To the present day, it is under designing work by a design engineer.
