# Technical Investigation in GW Contamination Assessment (Pak Chong Case Study)

presented at  
International Workshop on Safe Soil  
and Groundwater Resources in Asia

By  
Assoc. Prof. Dr. Sucharit Koontanakulvong and team  
September 22, 2008.

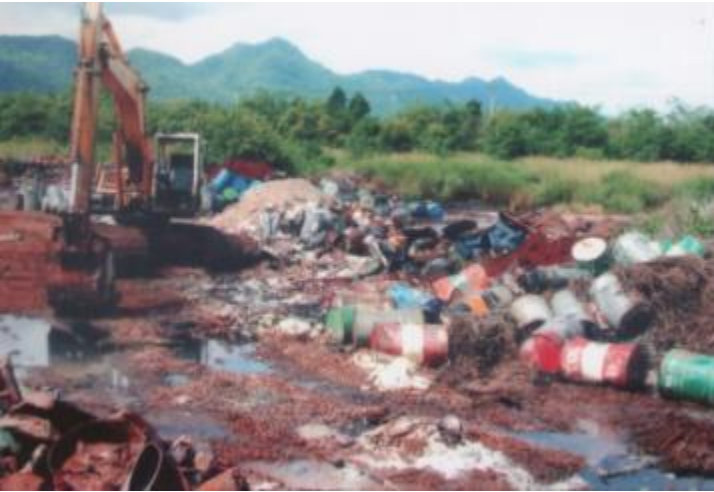
- ❑ **Night dumping in Pakchong area, Nakornratchasima Province (2004)**

- ❑ **Soil removal for the 1 – 2 meter top soil with new soil substituted about 1 m based on contamination level**

- ❑ **PCD and DGR set monitoring wells and found TCE and Benzene exceeded than standards**

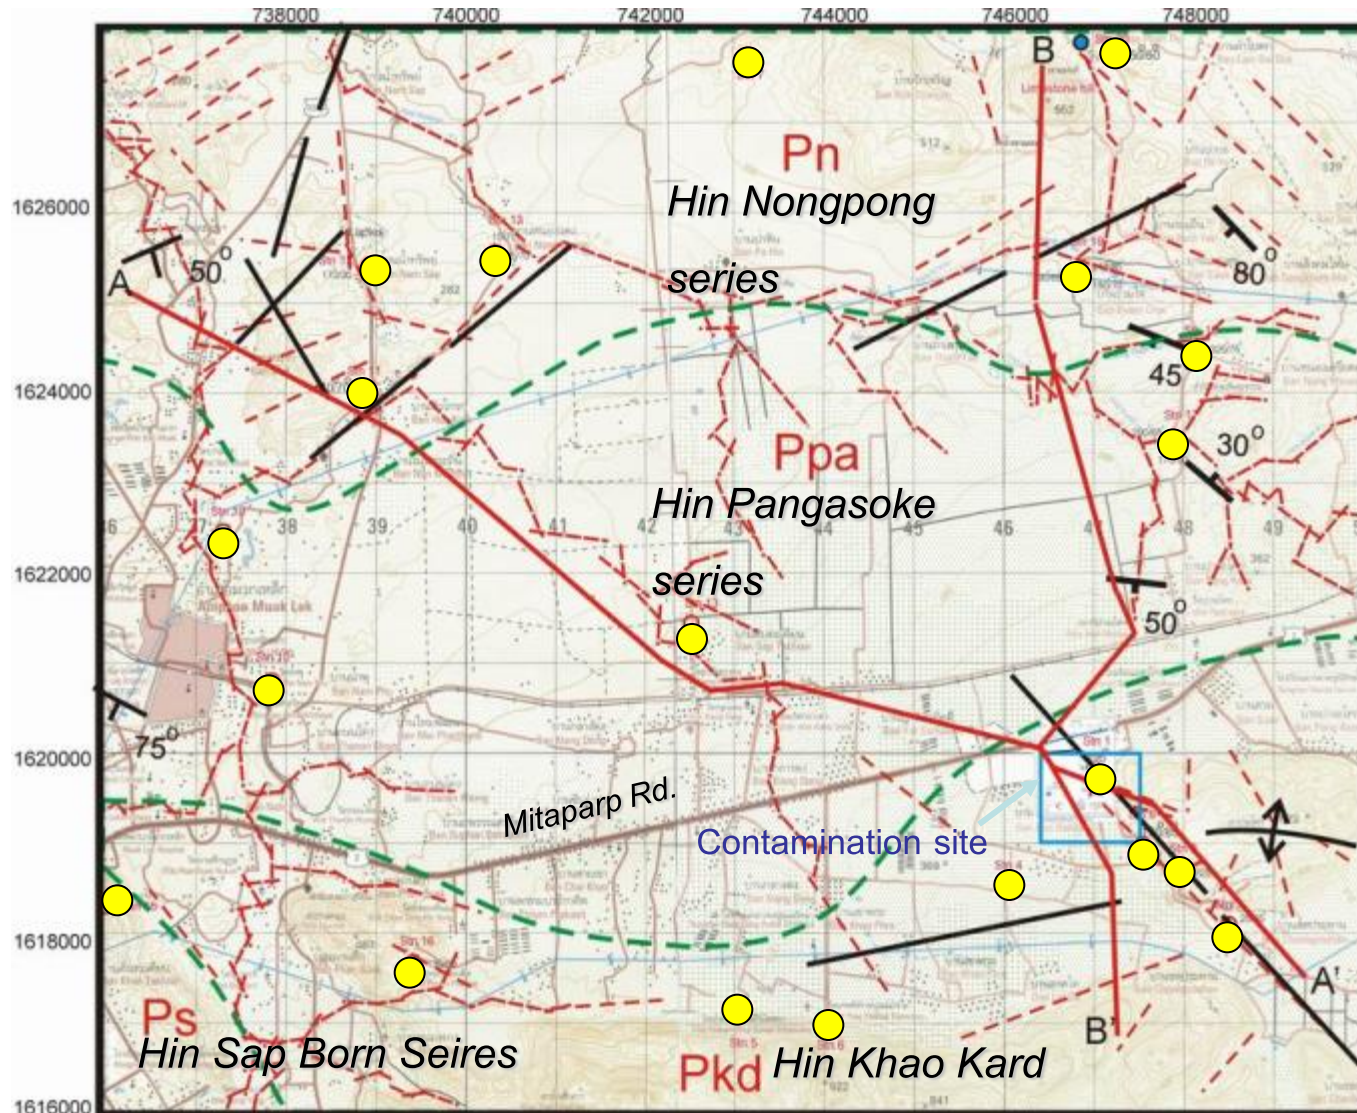
# Fractures alignment

2 main routes ■ SE - NW  
■ NE - SW

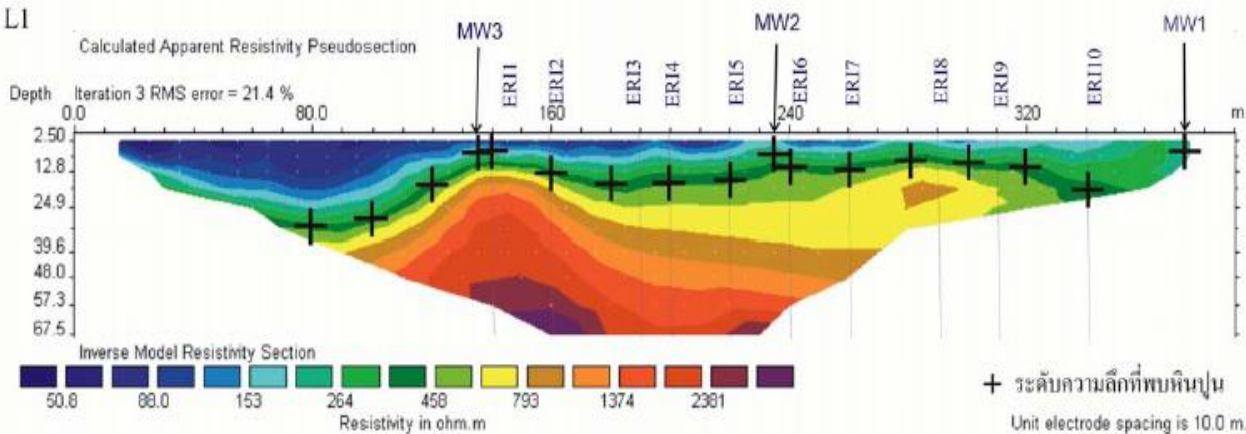
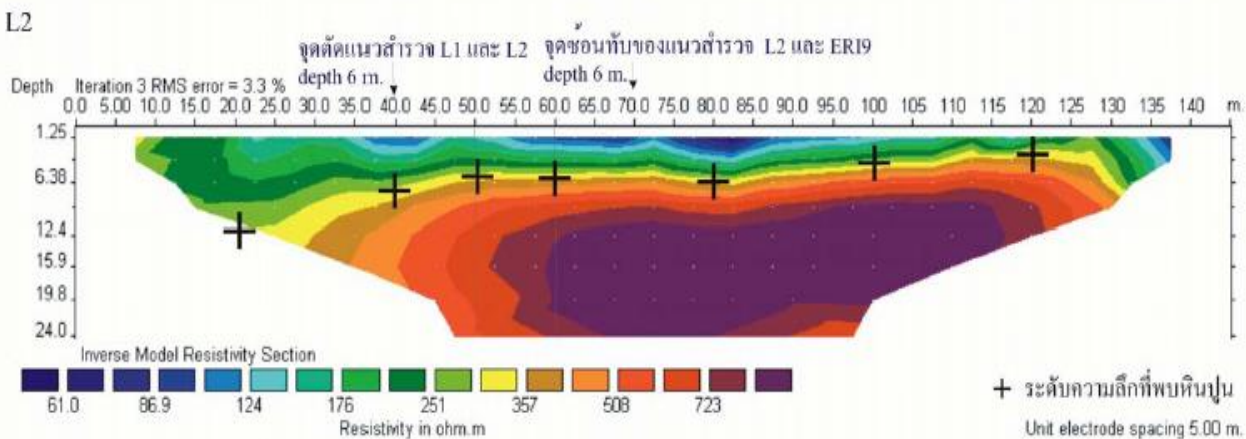
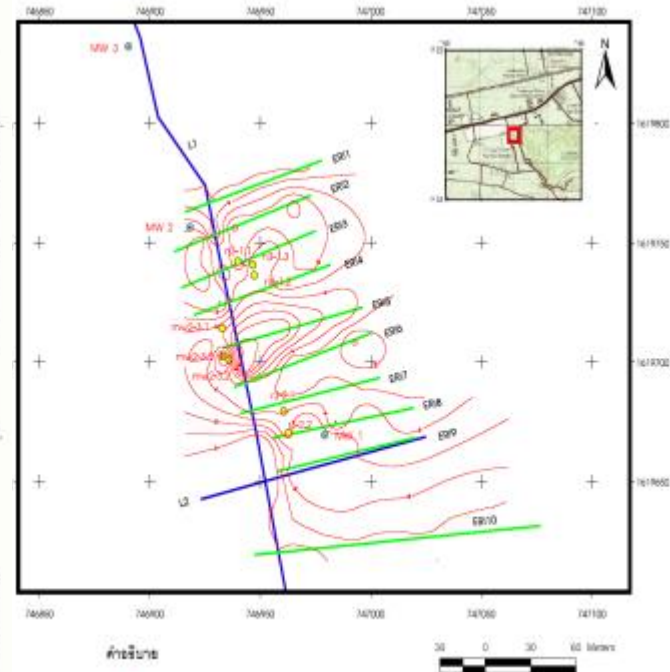
# Cross sectional Resistivity of Soil Surface

Cross sectional distribution from RES2DDINV program  
(Wenner Pole Type)

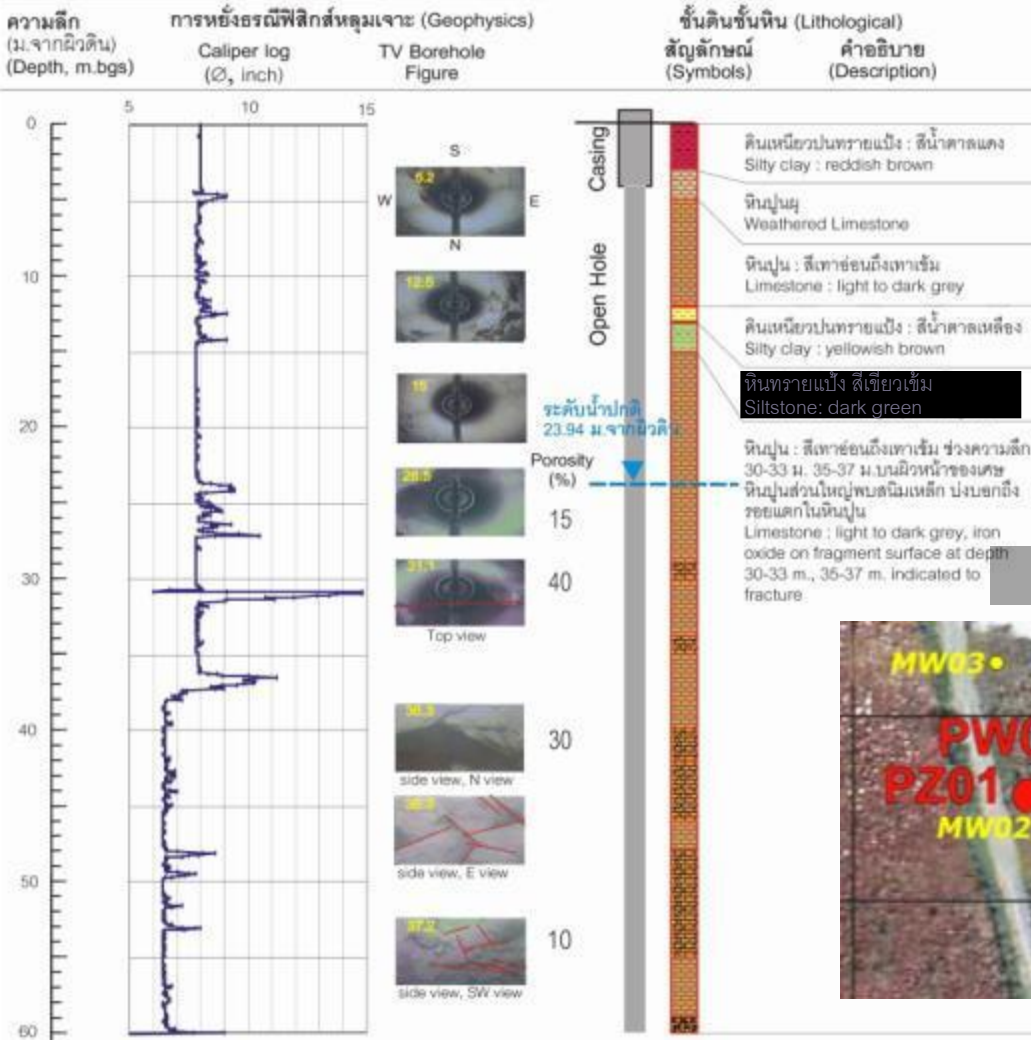
หมายเลขบ่อ PZ01 วันที่เจาะเสร็จ 03/02/2550 ความลึกเจาะ 60 ม. ระดับความสูง 377.774 ม.ทก.  
ท่อกันพัง Ø 8" ความลึก 6 ม. ระดับน้ำปกติ 23.94 ม.จากผิวดิน วันที่ตรวจวัด 05/02/2550

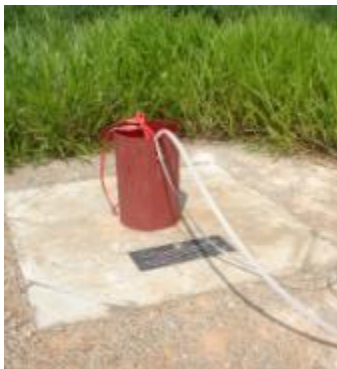
- ❑ VOCs Past records (PCD)
- ❑ VOCs present records (included Pesticides and Heavy Metals)
  - soil (2-5 m; Nov 2006) : VOCs, Pesticides not found  
: Heavy Metals found (within standards)
  - GW (26-70 m; Feb & June 2007) : Pesticides not found  
: Heavy Metals found (within standards)  
: VOCs ( 7 types exceeded standards)

*Based on soil and ground water quality standards by ONEP (2000, 2003)*

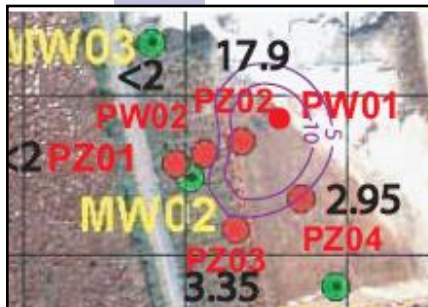
### Benzene: LNAPL

## Hot Spots: LNAPL, DNAPL

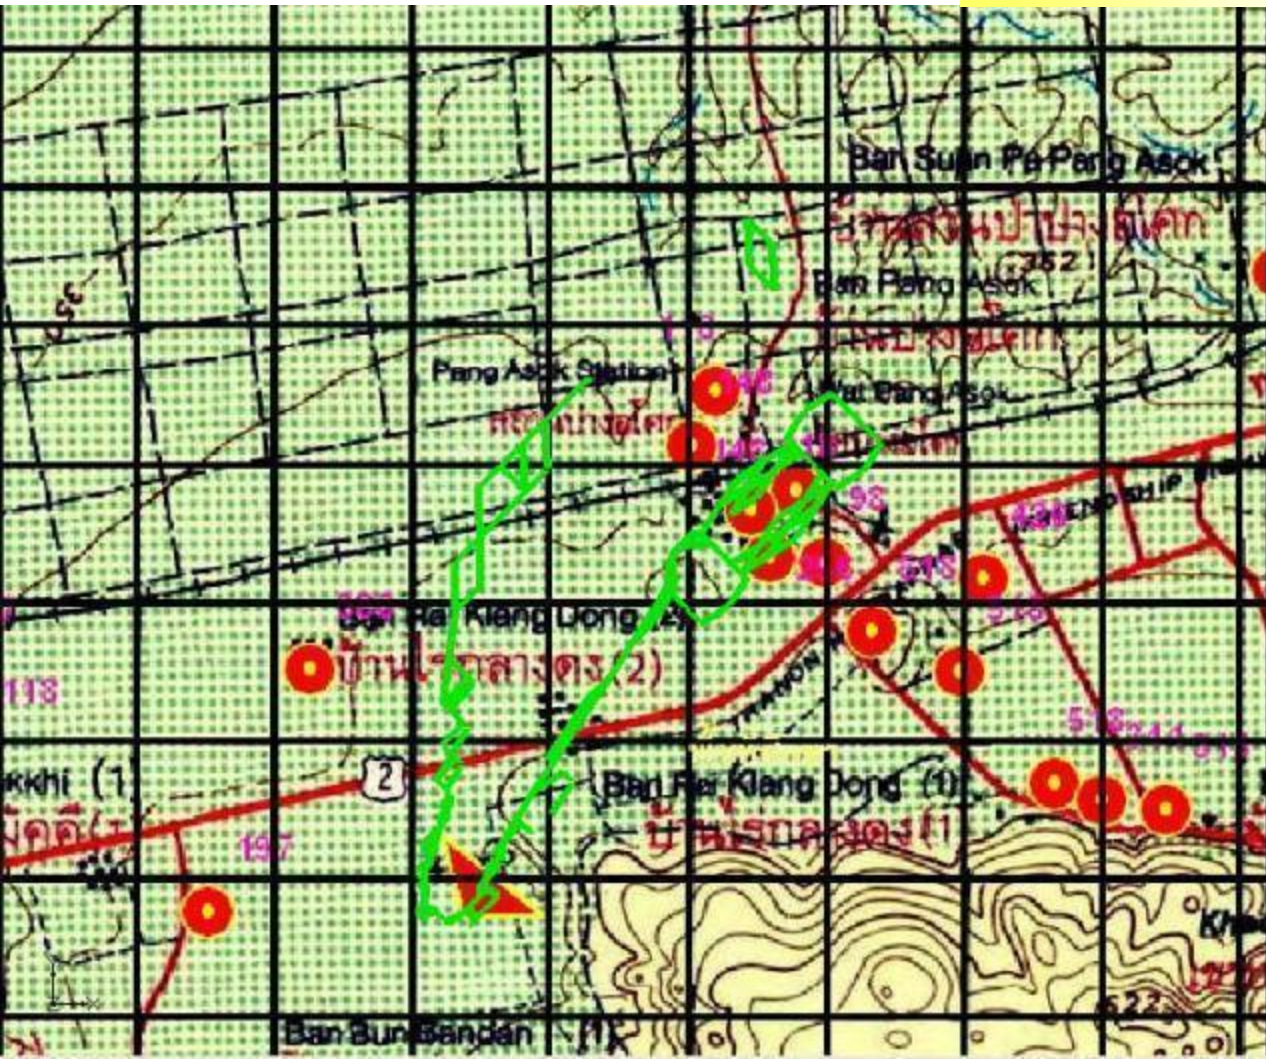
Year = 50

## Distribution of TCE Concentration in groundwater

- More detailed site characterization
- Regular monitoring system needed
- Proper planning for clean up action
