# **Model of water leakage beneath reservoir and above diversion water tunnel; Mae Prachum reservoir area, Mae Taeng District, Chiang Mai Province**

**Bureau of Engineering Topographical and Geotechnical Survey  
Royal Irrigation Department, Samsen rd., Bangkok, Thailand**

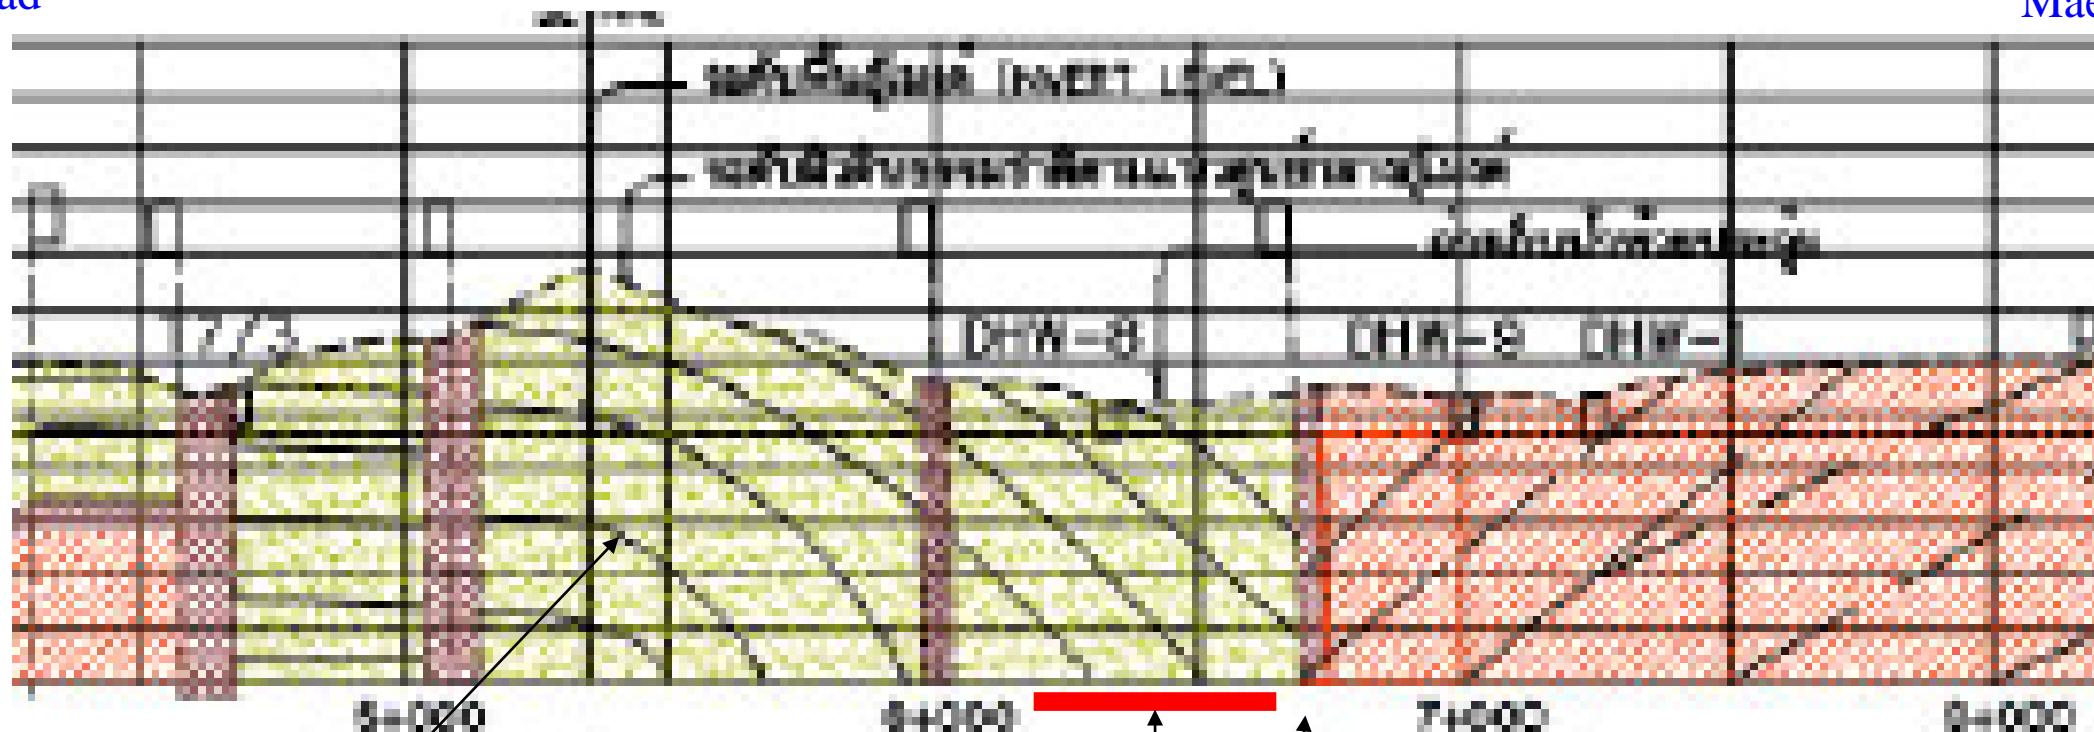
# Geological prediction of foundation of Mae Prachum reservoir

Low-angle Thrust fault

Fracture / Fault / Sheared zone

Fracture / Fault / Sheared zone / Rock unit

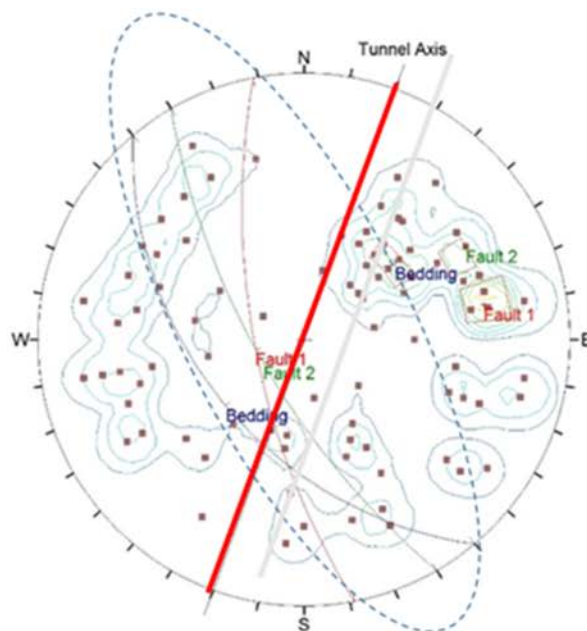
# Structure controlled; Fracture and Fold associated Fault

Discontinuities  
Avr. N27°W 63°SW

Type	Strike/Dip (Right)
Fault 1	169/69
Bedding	140/48
Fault 2	150/72
