Flood Risk Management in Delta Areas of Myanmar

Dr. Hrin Nei Thiam
Director General
Department of Meteorology and Hydrology

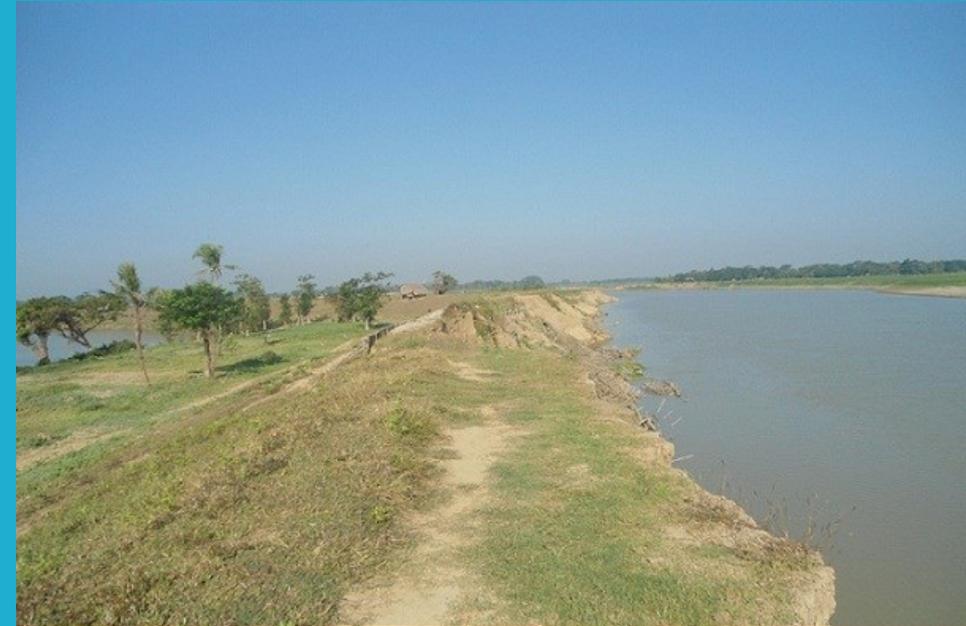
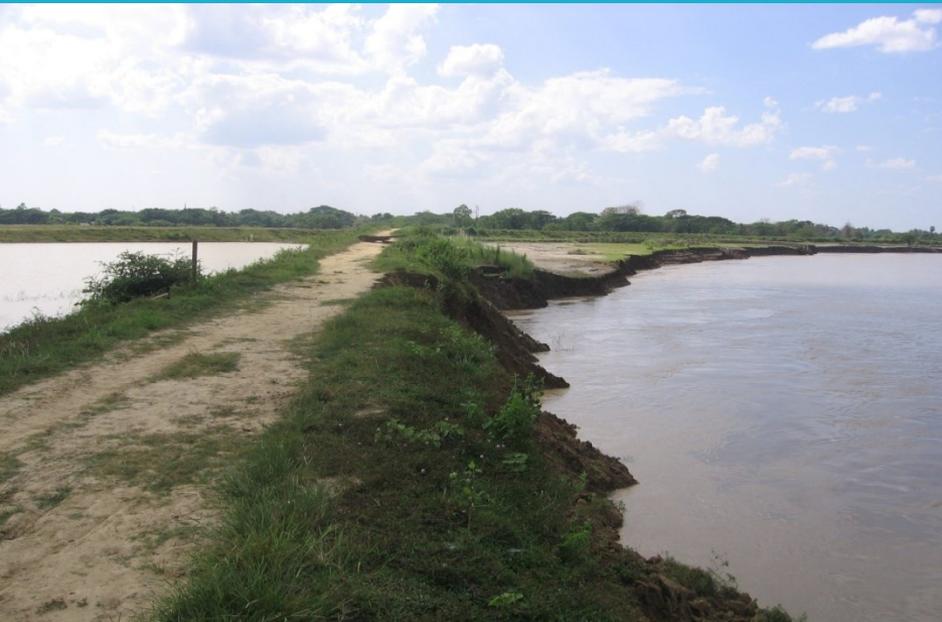
- ❑ Before monsoon, inspection is made along the dikes to ascertain where the maintenance and rehabilitation works are required

- ❑ Engineering staff and his labour groups inspect along the dikes to find out
 - Weak portion of embankments
 - Bank erosion

- Settled portion in crest level,
- Holes made by insects or animals
- And also, bushes growing on the slope and the toe of the dikes on land side are also cleared
- so that seepage, sand boils and any other fault, can be seen

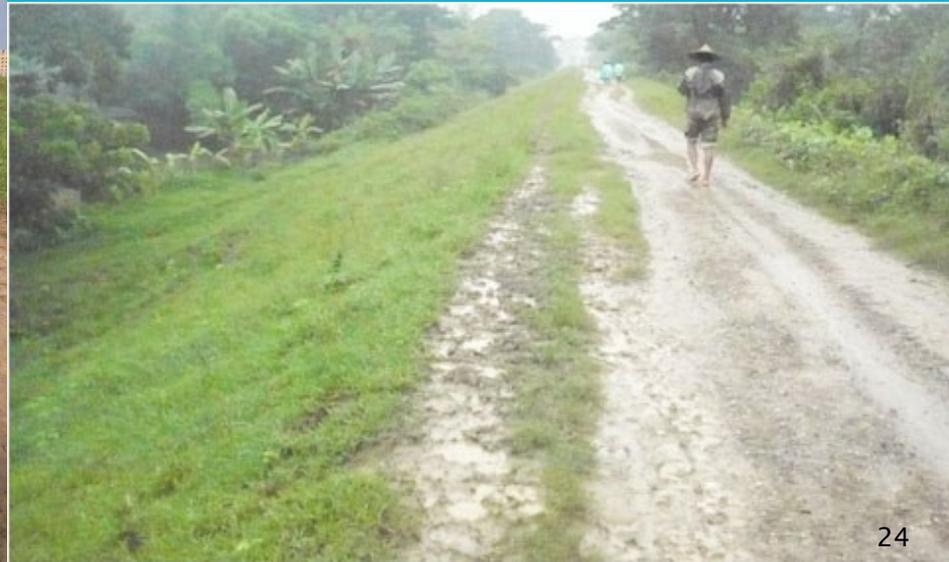
Investigation during monsoon

Engineers and workmen are deployed at temporary huts when flood level reaches or above the danger level.

- ❑ Embankments are watched both day and night.
- ❑ During daylight Engineers are on inspection, one or two of labours are deputed to walk along the dikes for their assigned portion
 - generally 4 mile in length, once or twice during the day.

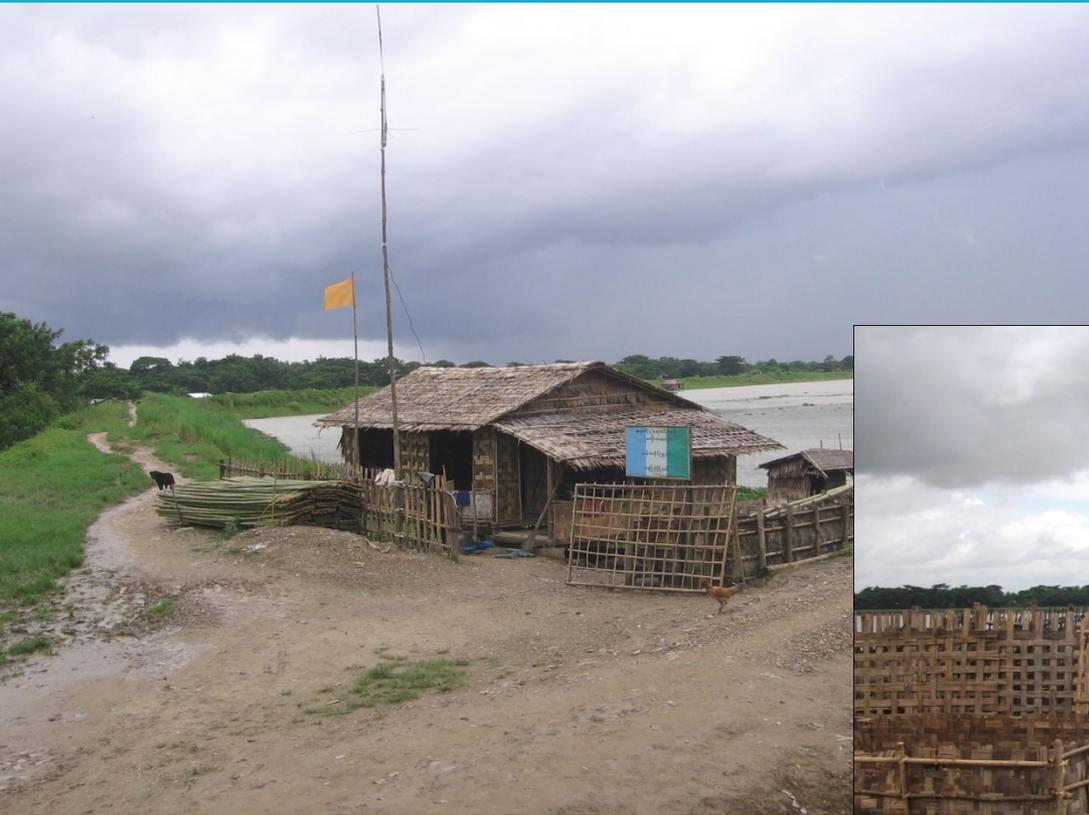
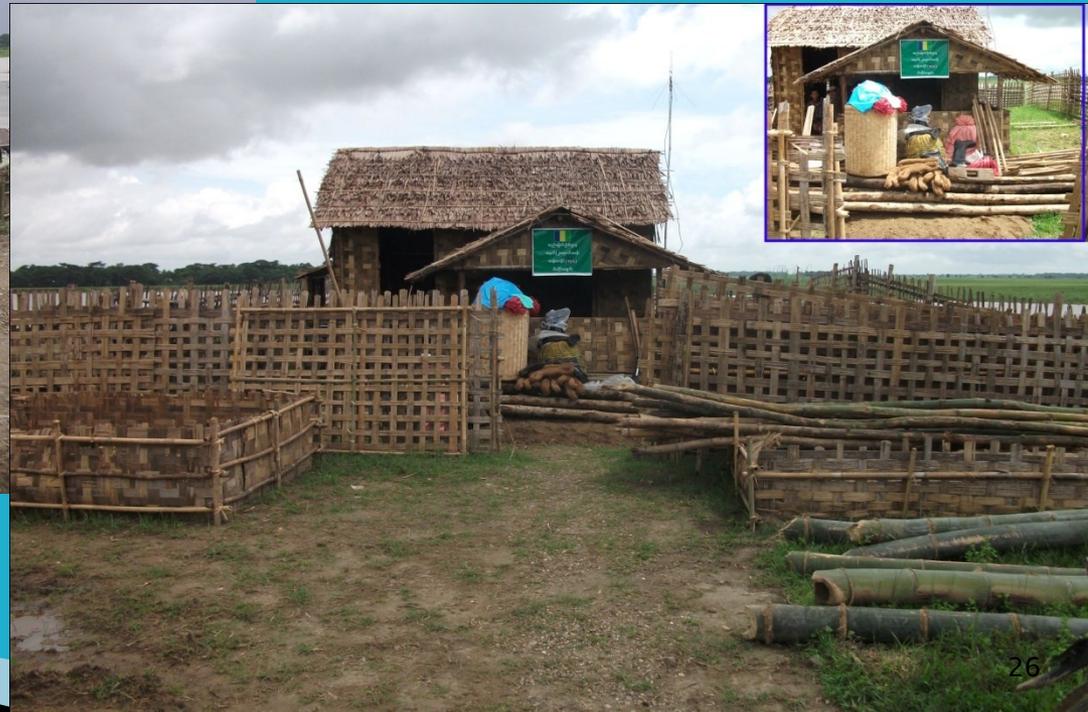
- ❑ Temporary huts (beats) are built at 4 mile (6.4 km) interval along the embankments for resting of the inspectors and all necessary emergency materials are collected so that emergency counter measure can be taken without delay.

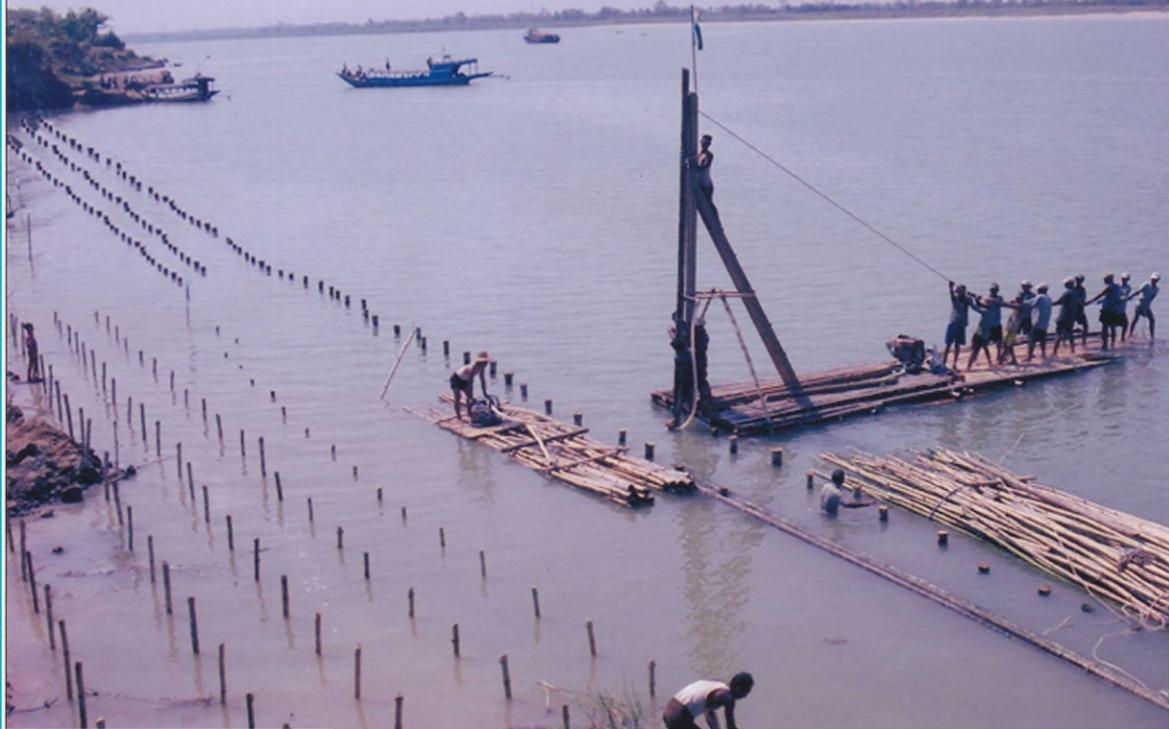
- ✓ Protection work to prevent bank erosion is done before the flood season,
 - Constructing deflection spurs
 - Construction diamond spurs (Siltng spurs)

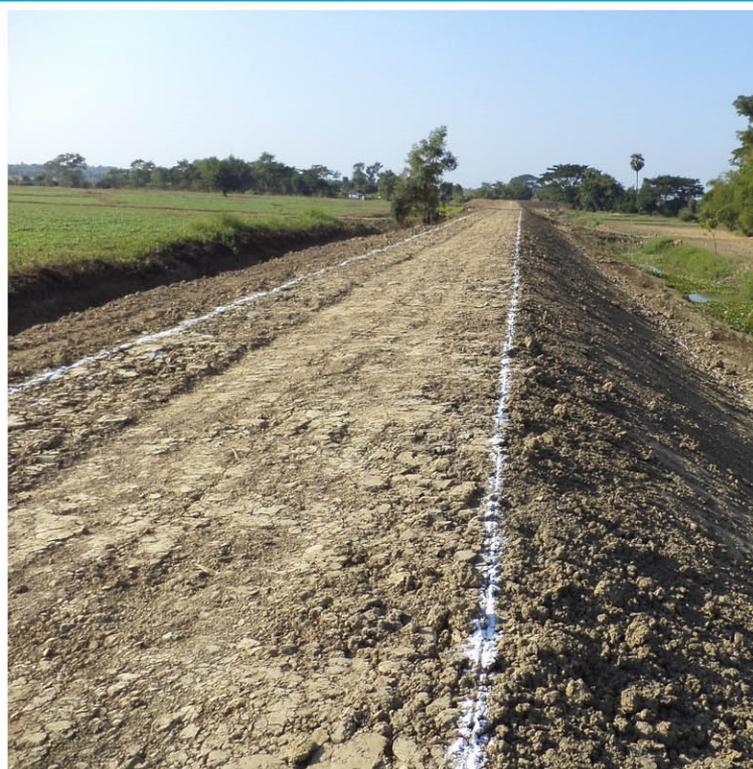
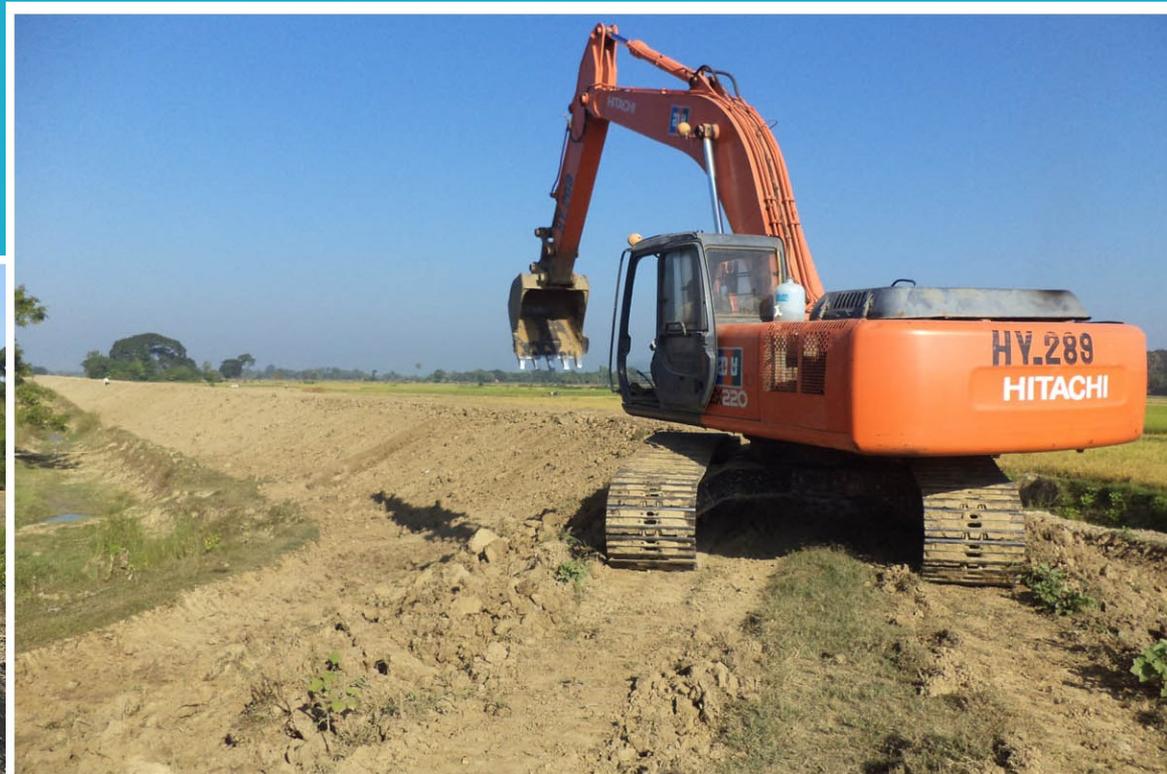
- ✓ Clearing bushes and grass at the land side of dike slope
- ✓ Repairing of water level gauge
- ✓ Re-sectioning and strengthening of dikes

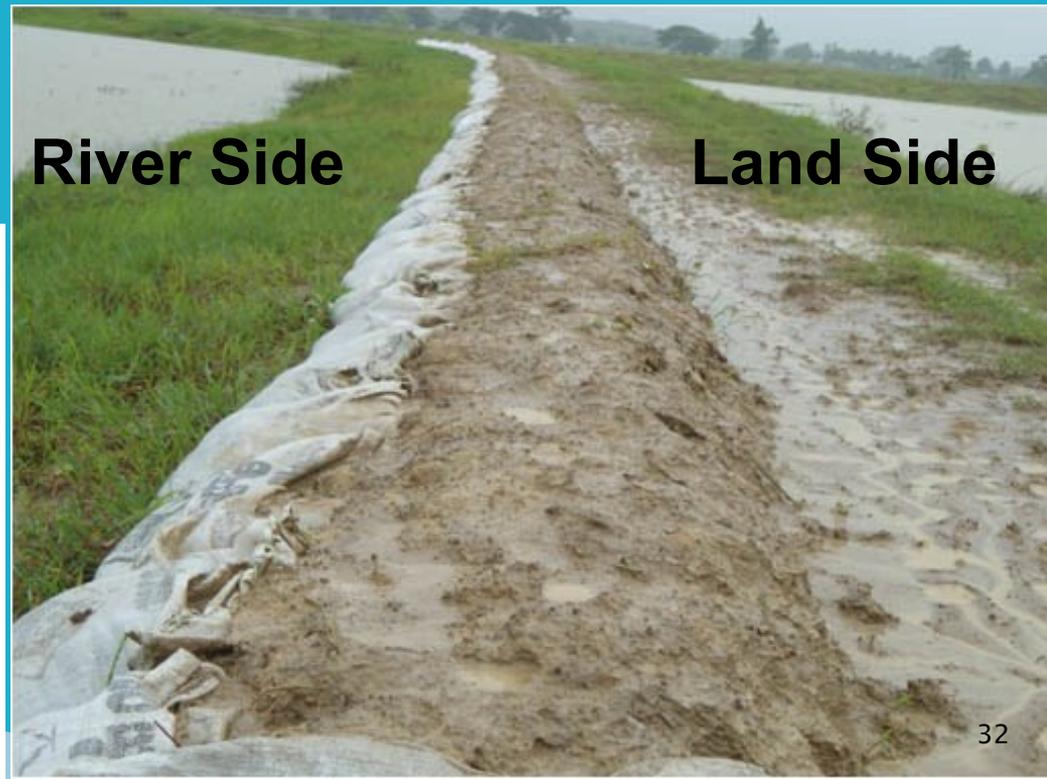
During the rainy season

If **overtopping** occurs it is prevented from flowing over the bund, by exacting a small bund or *Kazin*
If soil is not available from elsewhere in time it can be obtained safely from the land side edge of the crest or raised by sand bags

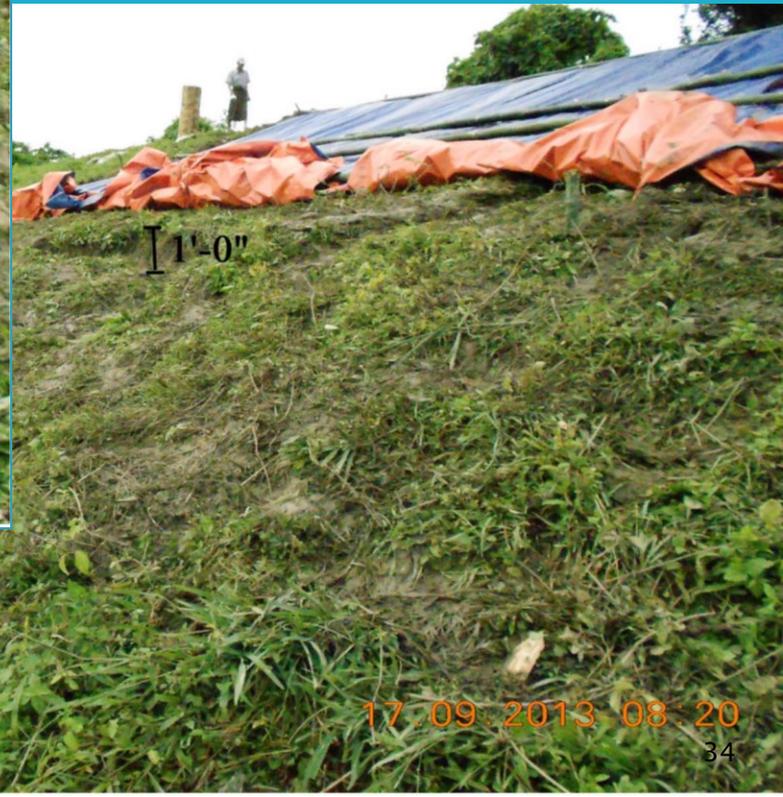
If **slip** occurs, to maintain the section and to weight the toe, countermeasure is taken by flattening the slopes or by providing a banquette cover by waterproof material to prevent from entering of rain water into the crack of the slip.
